Kaikoura Earthquake – One Year On

Acknowledgements: This *Geography Factsheet* was researched and written by **Sue Warn**, who visited Kaikoura in November 2017 on the anniversary of the 2016 earthquake, and published in **April 2018** by **Curriculum Press**. Geo Factsheets may be copied free of charge by teaching staff or students, provided that their school is a registered subscriber. No part of these Factsheets may be reproduced, stored in a retrieval system, or transmitted, in any other form or by any other means, without the prior permission of the publisher. **ISSN 1351-5136**

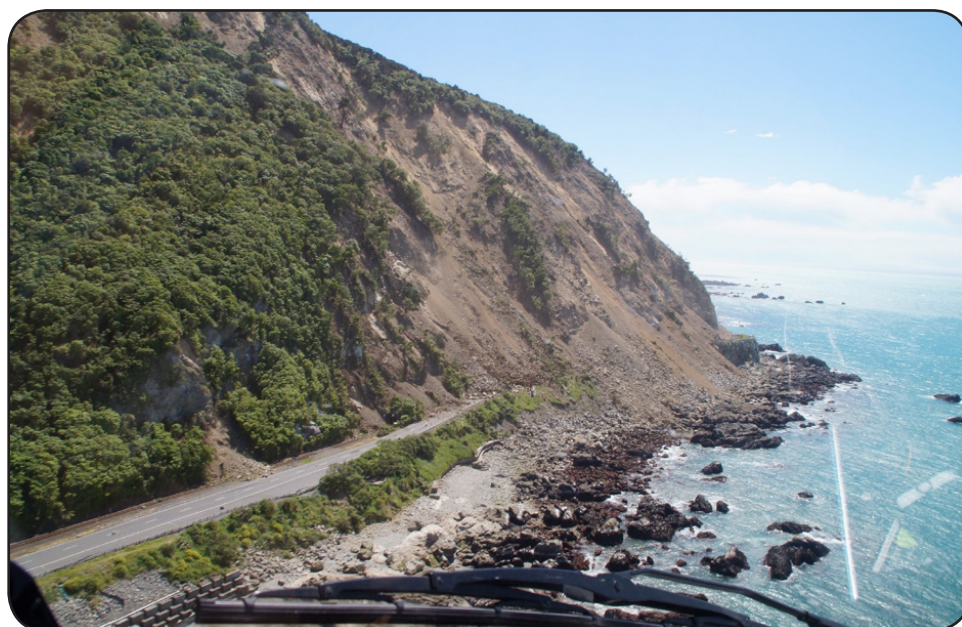
Figure 4 Landslides showing damage to the infrastructure – both road and railway

Landslides affected a total area of 10,000 square km with the majority concentrated in a smaller area of about 3,500 km². Some 80,000-100,000 were mapped. Local geology, relief and the degree of ground shaking were the key causal factors affecting distribution with sedimentary sandstones, limestones and clays being the main rock types affected. A wide variety of landslide types occurred ranging from rotational rockslides to rock and debris avalanches. Many of the landslides (190) were very large and actually blocked river valleys, e.g. Hapuku. They represent, until managed, a potential risk to agriculture, aquaculture and infrastructure as they can be reactivated by heavy rain or ground shaking from aftershocks forming temporary dams. The landslides were also concentrated along the steep coastal cliffs which had major implications for the communications networks – perhaps the **key impact** of the earthquake.

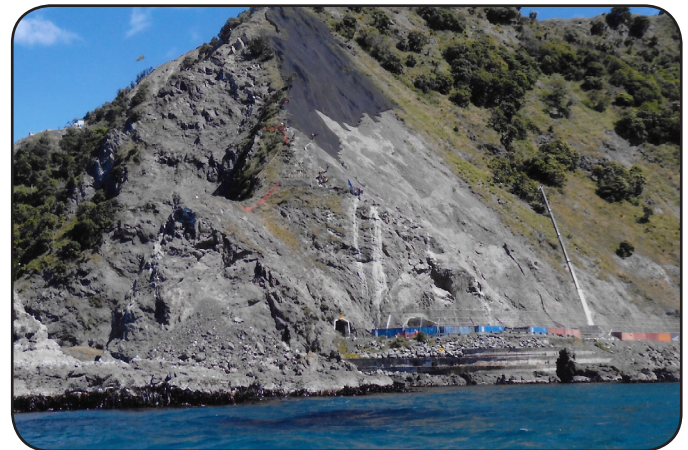
Figure 7 Engineering works

Figure 7 shows the complex nature of the repairs and the massive scale of the engineering works.
